Forest Aquatic Restoration Project NEPA Compliance and Implementation Checklist

Date: March 21, 2016

Title & Category: Headwaters Spring Protection / Category 9

Site visits to 8 Spring Sites on May 11, 2015 by Gale Shepard, Jaime McCormick, Hazel Owens, and Bill Wall for the consideration of protecting and restoring these springs.

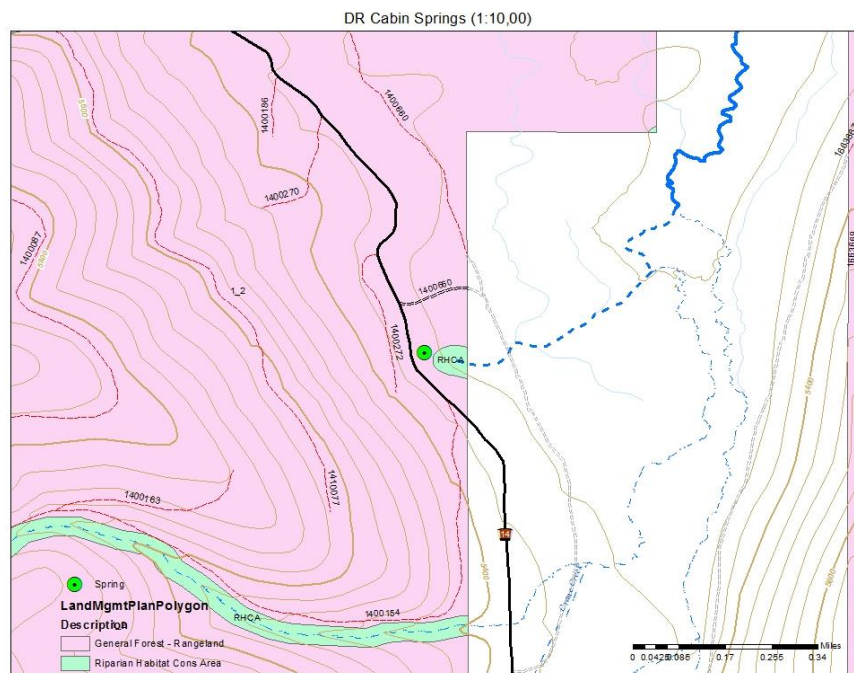
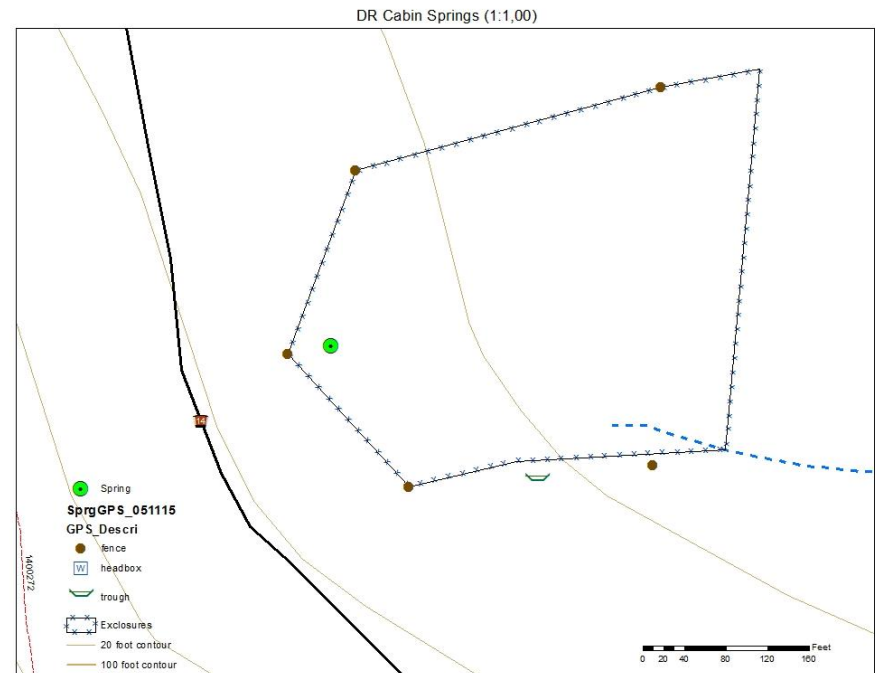
DR Cabin Springs

Good Flow. Spring temperature @ 0830 was 44°F. No head box; piped only. Should not be an issue with shared flow. Mounded fens present. Diverse riparian vegetation. Hoof action herbivory, and browse impacts are visible. Pipe would run to trough through old ditch. Would require float at trough due to distance from main downstream flow. However, if botany is able to determine that vegetation would not be affected with overflow as planned, then a float would not be required. Very good project for restoration. This project would fit category 9 of the Aquatic restoration EA, assuming there are no negative effects to TES botanical species.

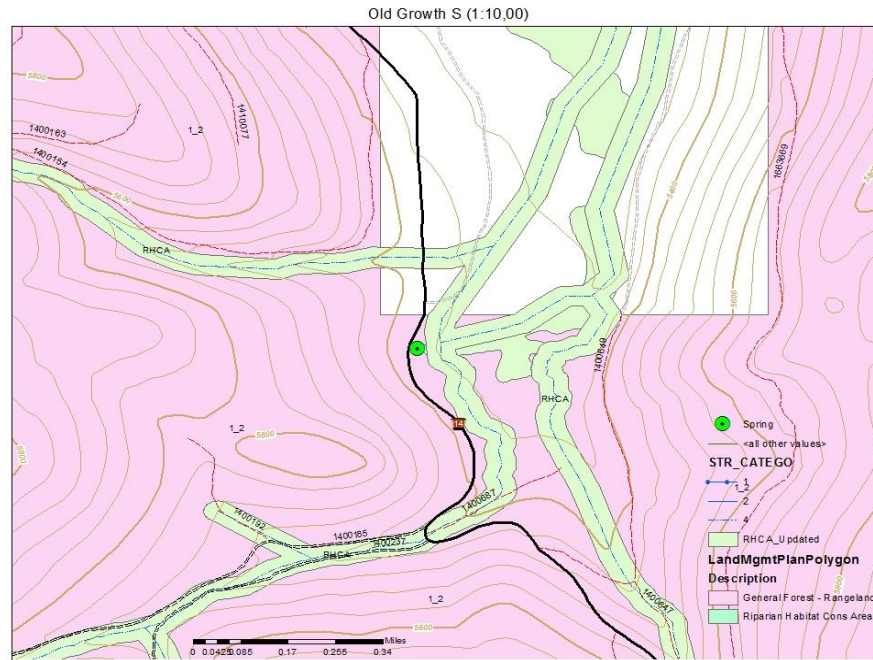
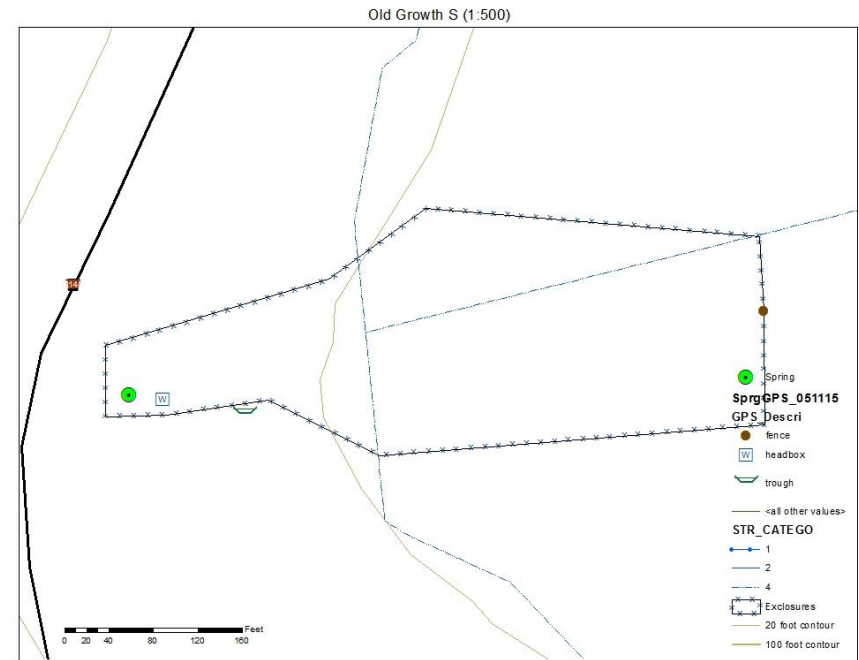
Old Growth S Springs

Flows are moderately low. Spring temperature @ 0920 was 44°F. Would require float valve at the trough due to insufficient surface flow for spring and trough to maintain present saturated soils. Distance from proposed head box to trough is approximately 55 ft. Effect of surface saturation may be most evident be within this distance. There is likely to be adequate near surface ground water to not measurably affect riparian vegetation. Would not need to perk the springs to get adequate flow to trough. Hoof action, and grazing impacts are visible. Since it is not necessary to perk the springs and the near surface ground water and riparian

vegetation can be maintained, this project would fit category 9 of the Aquatic restoration EA. This is assuming there are no negative effects to TES botanical species.

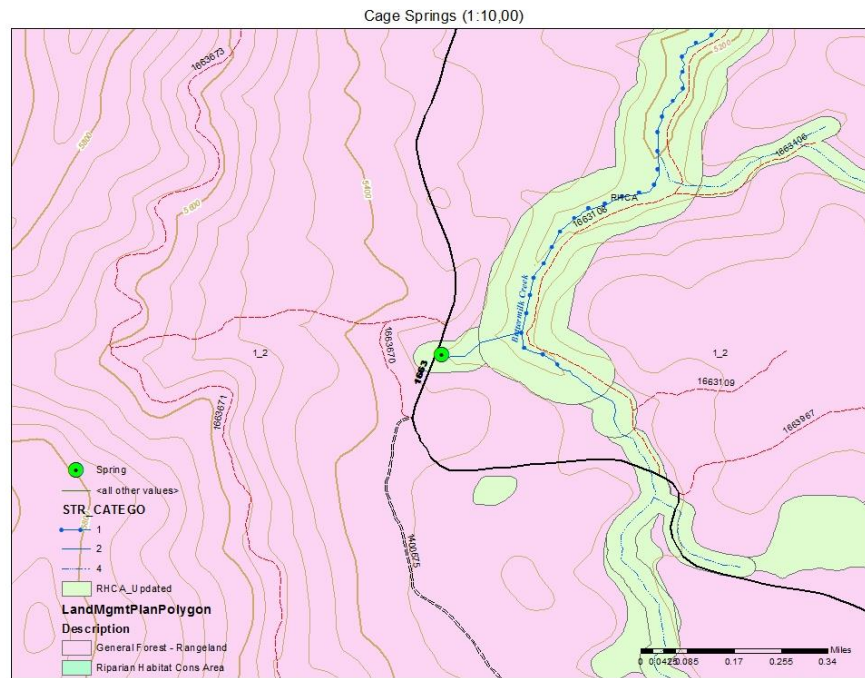
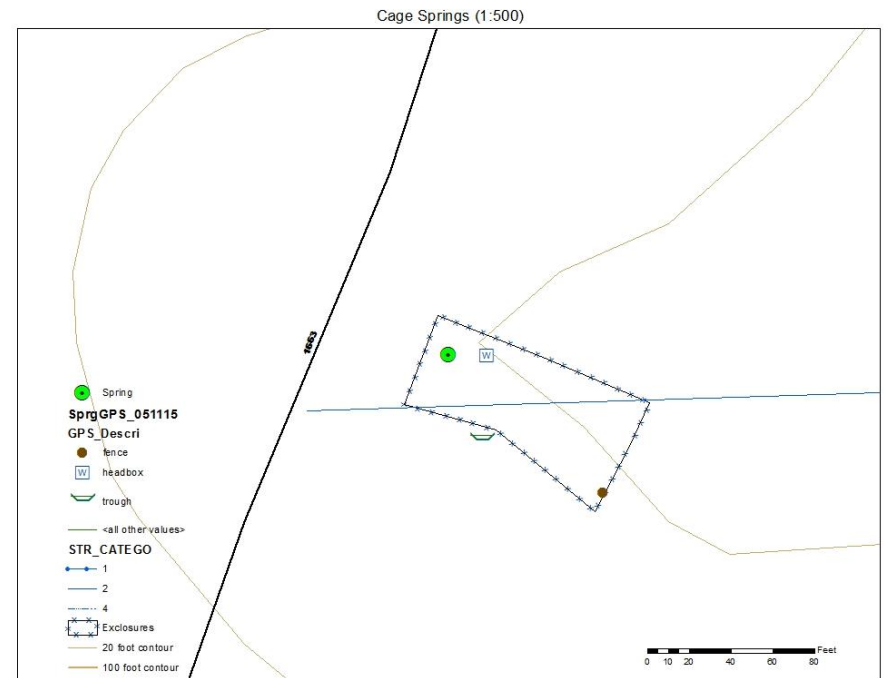
Cage Springs

Flows are moderately low. Spring temperature @ 1015 was 44°F. May require float valve at the trough due to insufficient surface flow for spring and trough to maintain present saturated soils. However, if botany is able to determine that vegetation would not be affected with overflow as planned, then a float would not be required. Distance from proposed head box to trough is approximately 35 ft. Effect of surface saturation would likely be within this distance. There is a low diversity of riparian vegetation and is not continuous down drainage. Would not need to perk the springs to get adequate flow to trough. Hoof action and grazing impacts are visible. Drainage runs into Buttermilk Creek. Since it is not necessary to perk the springs and the near surface ground water and riparian vegetation would be maintained, this project would fit category 9 of the Aquatic restoration EA. This is assuming there are no negative effects to TES botanical species.

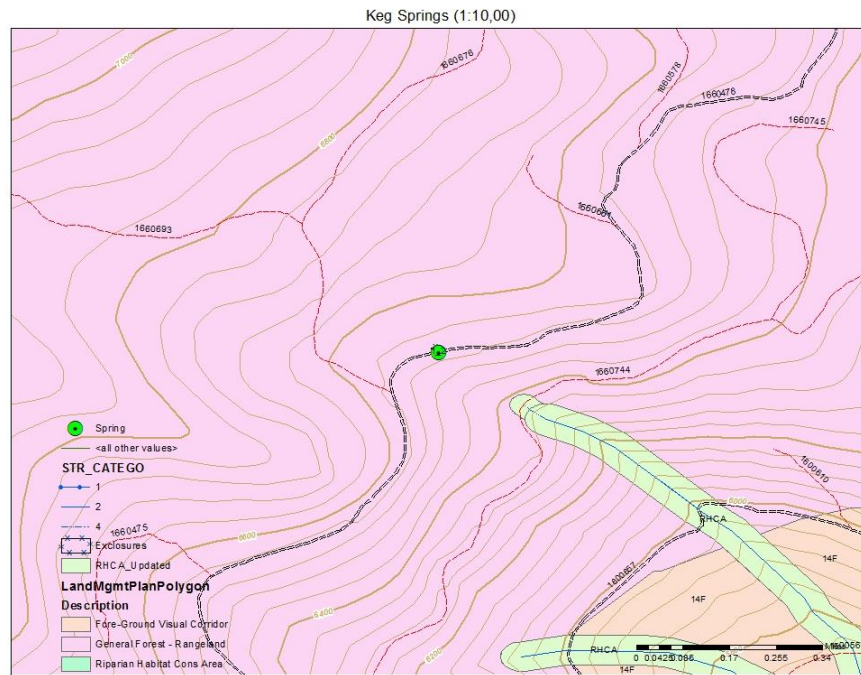
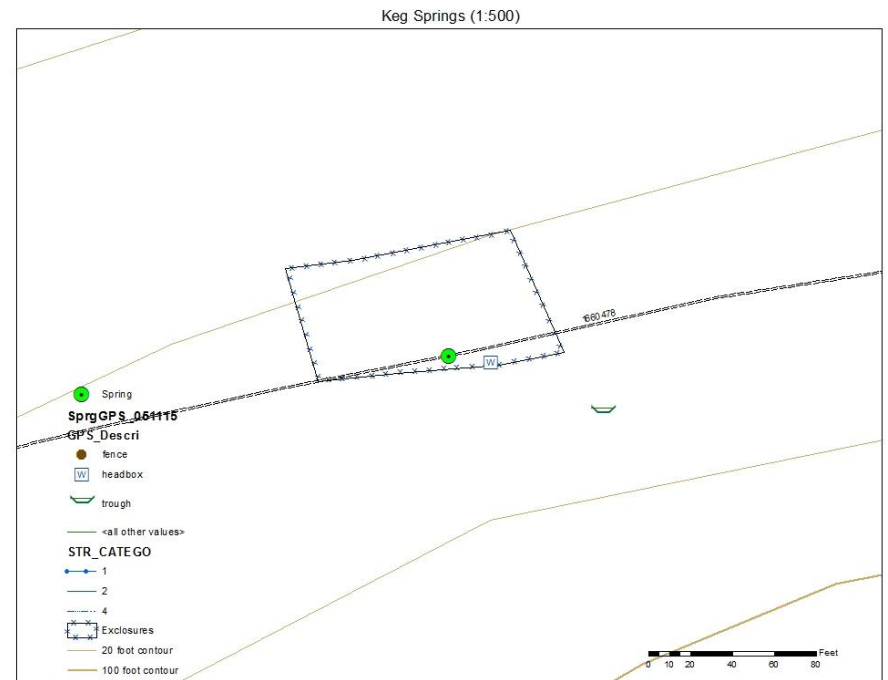
Keg Springs

Good Flow. Spring temperature @ 1145 was 49°F. Road prism is associated with spring. Area is boulder/cobble. Possible to pipe flows without head box, but may be too much sediment at present. Head box would be essentially within the inboard ditch of the road. Spring runs through a ditch to a stock pond that is on the opposite side of the road. Heavy sediment loads have filled the stock pond. Plan is to fill in the stock pond (not much fill needed) and place a trough in the same area with an overflow back to the drainage, which is close. Drainage downstream is dry within 30 feet of the old stock pond. Substrate is mostly small boulder. Drainage is the headwaters of Halfway Creek. Heavy impacts from hoof action and grazing are present. Project as proposed should allow significant recovery. Very good project for restoration. This project would fit category 9 of the Aquatic restoration EA, assuming there are no negative effects to TES botanical species.

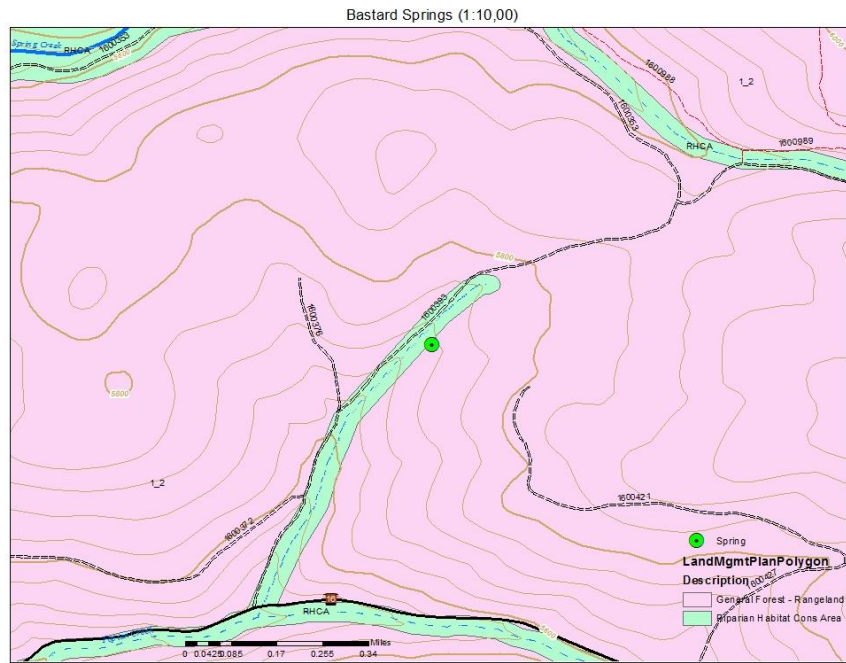
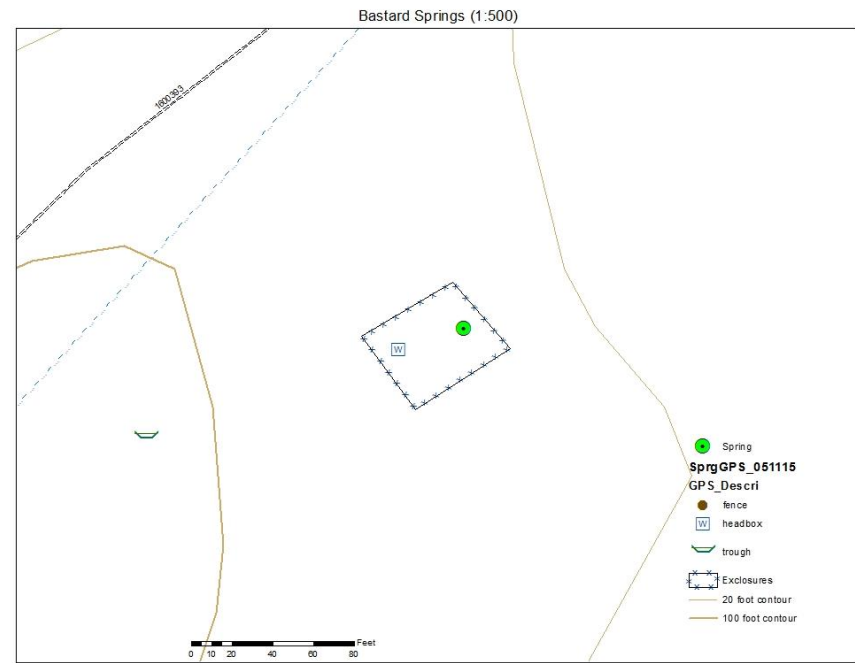
Bastard Springs

Very low flow. Did not record temperature by accident. May need to perk the springs to get adequate flow to trough. Head box would be placed at downstream end of pond. Pond is heavily silted in with very low diversity of riparian vegetation, likely due to hoof action and grazing impacts. Pond would be fenced to allow for veg recovery. Perking the springs may reduce recovery, but there would not likely be a loss of present diversity of vegetation. Would require float valve at the trough due to insufficient surface flow for spring and trough to maintain present saturated soils. Trough would be place as close to head box as possible, though presently proposed at approximately 90 ft. Due to low flow drainage would likely go dry for these 90 feet. What riparian vegetation is present is not continuous downstream. Flow from pond appeared to be less than 250 ft. Drainage has minimal riparian veg between the pond and Fopian Creek. Since the near surface ground water and riparian vegetation can be maintained, this project would fit category 9 of the Aquatic restoration EA. This is assuming there are no negative effects to TES botanical species.

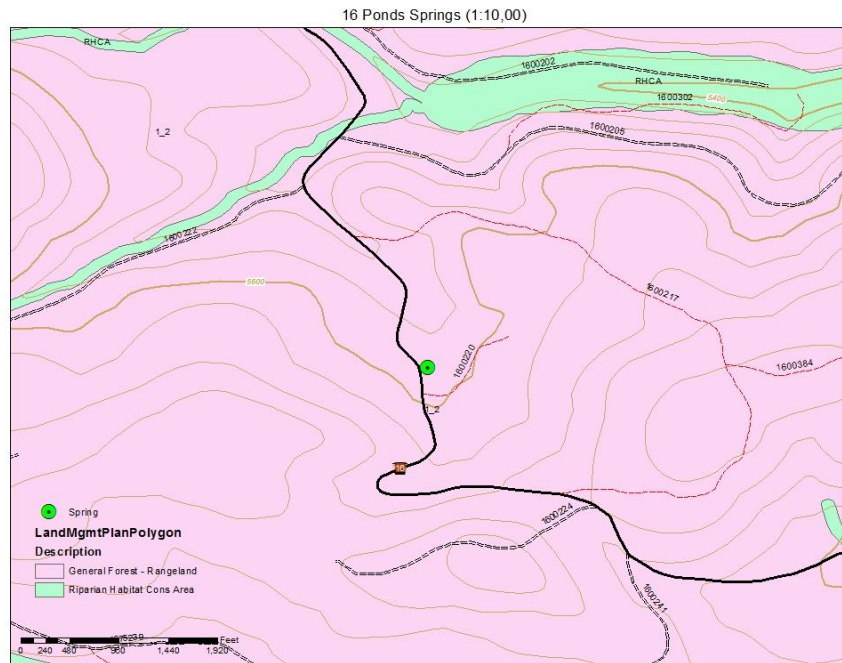
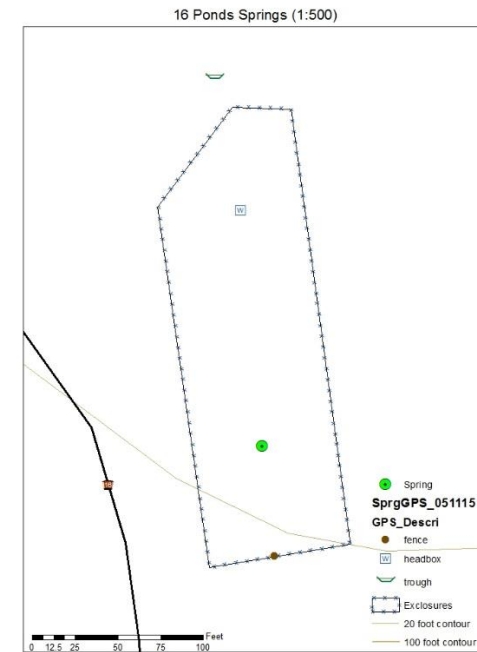
16 Ponds Springs

Moderate flow. Spring temperature @ 1240 was 54°F. Distance from proposed head box to trough is approximately 80 ft. Effect of surface saturation would likely be within this distance. Likely to be adequate near surface ground water to not measurably affect riparian vegetation. Would not need to perk springs to get adequate flow to trough. Hoof action, herbivory, and browse impacts are visible. Probably get excellent recovery of willows and herbaceous vegetation. Very good project for restoration. This project would fit category 9 of the Aquatic restoration EA, assuming there are no negative effects to TES botanical species.
